Mobile Intel[®] Pentium[®] II Processor Specification Update

Release Date: April 2006

Order Number: 243887-052

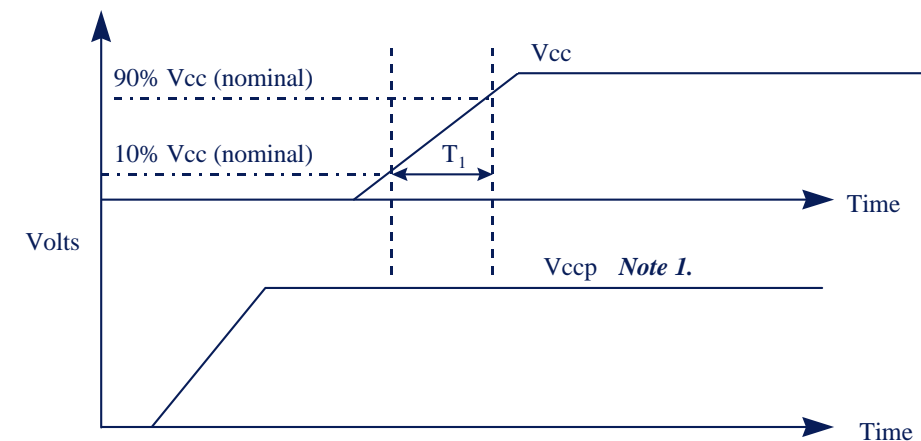
Figure 1. V_{CC}/V_{CCP} Timing Requirements (Mobile)

Problem: The processor uses the PWRGOOD signal to ensure that no voltage sequencing issues arise; no pin assertions should cause the processor to change its behavior until this signal is asserted, when all power supplies and clocks to the processor are valid and stable. However, if V_{CC} ramps up before V_{CCP} , it will cause the processor to enter an invalid state.

Implication: If this erratum occurs, the system may boot normally however, the L2 cache may not be initialized.

Workaround: For Mobile Pentium II processors, ensure that V_{CC} ramps after or with the L2 cache IO voltage (V_{CCP}). If V_{CCP} ramps after the V_{CC} , a delay circuit can be placed on the core V_{CC} to ensure that V_{CC} ramps at the same time or after V_{CCP} as shown below in Figure 1.

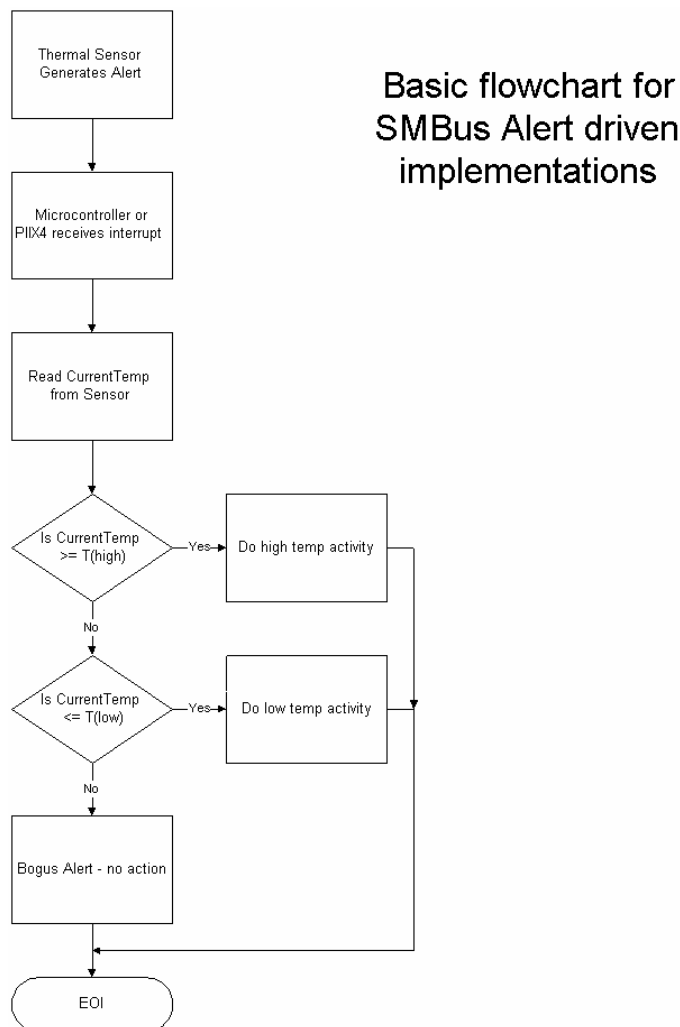
Figure 2. Workaround Flowchart: SMBALERT#-Driven System

Under the conditions described below, the thermal sensor incorrectly generates the SMBALERT# interrupt. All of the following conditions must be met to trigger a false interrupt:

1. Before servicing an interrupt from the thermal sensor, read and compare the processor thermal reading with the threshold limits (T_{HIGH} or T_{LOW}). Figures 2 and 3 provide basic flowcharts for the implementation of this workaround in an interrupt driven system.
2. If the firmware implemented polls the Status Register only, then before taking any action, re-read the temperature register and do a comparison with the alarm threshold limits (T_{HIGH} or T_{LOW}) to determine if the value is actually still within the temperature window.
